Community  
Archaeology

## The Lost Tower of Luddenham

Report for K82  
Luddenham Church, Luddenham,  
Near Faversham.

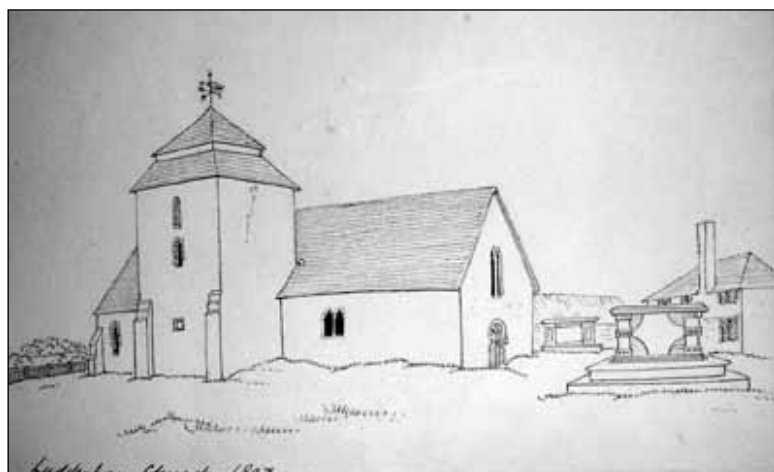
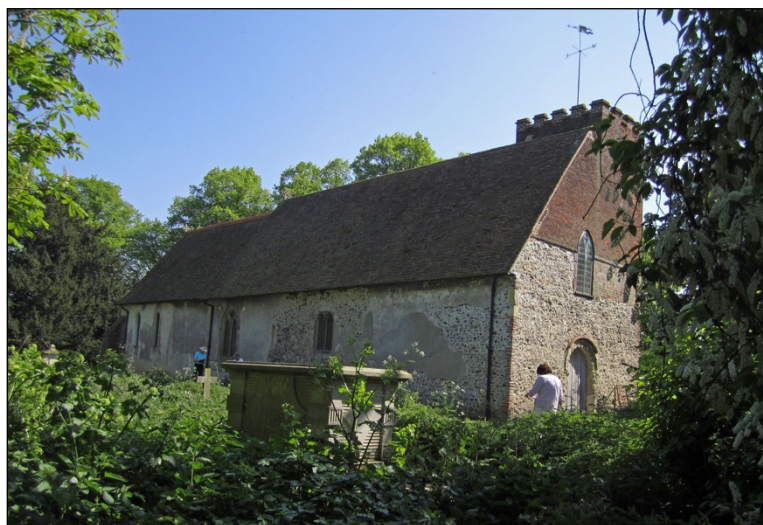
Now you see it (above, 1803<sup>1</sup>).....now you don't (below, 2011).

Documentary evidence tells us that the church tower, located on the north side of the church and containing three bells (see cover pictures), collapsed in 1806 or 7<sup>3</sup>, damaging the nave and chancel. The tower was replaced with what Newman<sup>4</sup> calls a 'puny red brick tower' at the south west corner of the church, and the damage to the body of the church repaired in 1807-8. All traces of the north tower disappeared.

use.<sup>7</sup> For the 'Lost Tower' project (see cover pictures), investigation was entirely focussed on the church and churchyard. The prints shown on the cover were very useful in deciding where to carry out the geo-resistivity survey. In interpreting the findings, however, the church does need to be seen within its very special landscape, as will become evident later.

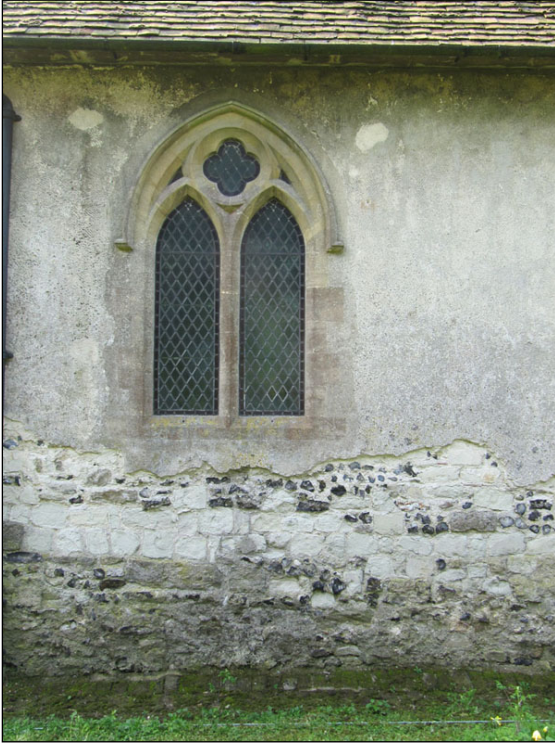
**Fig 3: The north wall with infill of the gap created by the tower collapse. The window is modern (note the falling away of the render).**

Other significant observations came from the building materials survey. Except for the west front and the chancel buttresses, the church is coated with render - excellent for water proofing but not helpful to anyone interested in building materials. Happily for us the render has fallen away in many areas and the actual build beneath is being temporarily revealed. Thus it was easy to see from a band of large squared stones exactly where the gap in the north wall, created by the disappearance of the tower, was filled in (**Fig 3**).

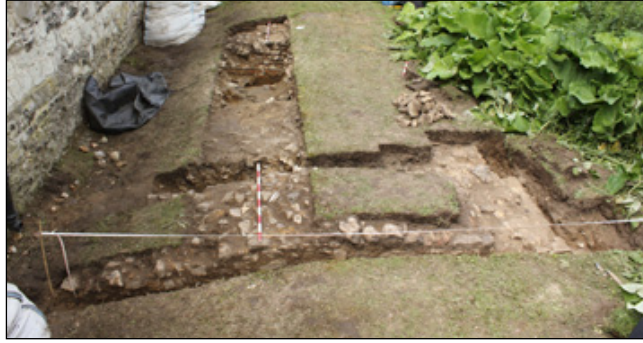
**Fig 4: Full extent of excavations. North to the right.**

All excavated soil was sieved meticulously, and the spoil heap and excavations scanned using a metal detector. Finds were set aside for each context and special finds were given three dimensional coordinates to pinpoint the exact find spot. The features revealed (**Fig 4**) were carefully recorded. Finally, the spoil was put back in, tamped down, watered and the turf replaced.

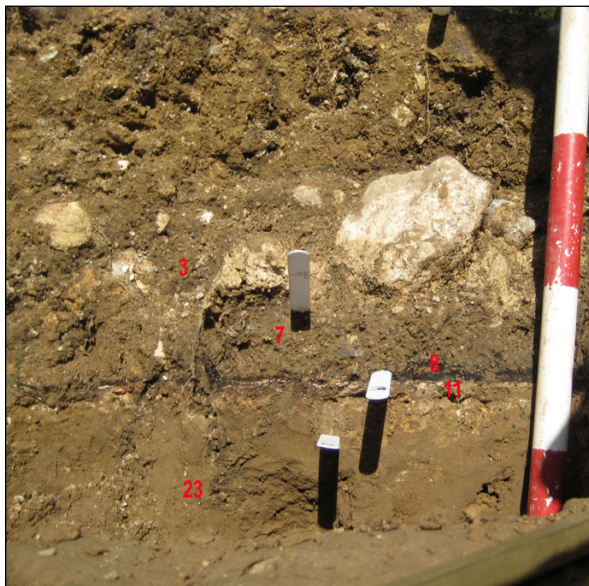
**Fig 4: Interface between layers [8] and [11] and the natural [23], in west facing exposure of unexcavated fill.**

The western half of the fill in between the walls was removed but the eastern half left in situ. The fill, divided by horizontal layers into [2], [3] and [7] contained huge amounts of building rubble (**Fig 7**). The top layer [2] was dominated by tile and mortared flint, the next layer down [3] had more mortar and flint and much less tile. At the base of these even layers was a patchier thin layer of brown clay with some charcoal flecks [7], overlying a thin black burned layer [8] which itself partially overlay a patchy deposit of hard white chalky- mortar like material [11]. These layers can very clearly be seen in section against the unexcavated section of the fill. [11] sits straight onto the natural brickearth [23] (**Fig 5**).

Identifying the actual tower foundations was not difficult. What did prove challenging was the dating of the burnt [8] and white [11] layers. As said above and seen in **Fig 4**, [11] rested on the natural brickearth. This might seem to imply that this is an old surface, contemporary or earlier than the wall foundations. Perhaps the postholes were for wooden scaffolding used in the building of the tower? The burnt layer, however, did *not* run underneath the base line of the wall - on the contrary, the lowest stones next to the burnt layer appeared somewhat scorched (**Fig 5**). So was this floor created after the tower collapse, with debris having been completely cleared away, including any floor coverings, right down to the natural soil? Was the sheltered area between the wall stumps used as a work area whilst the church was being restored? Were those came the remnants of the smashed windows (small tower windows are visible in the 1803 print)? Or are these leftovers from the making of the windows on site in around AD 1100? Was the circular mark made by a brazier (**Fig 6**) at either of these times?

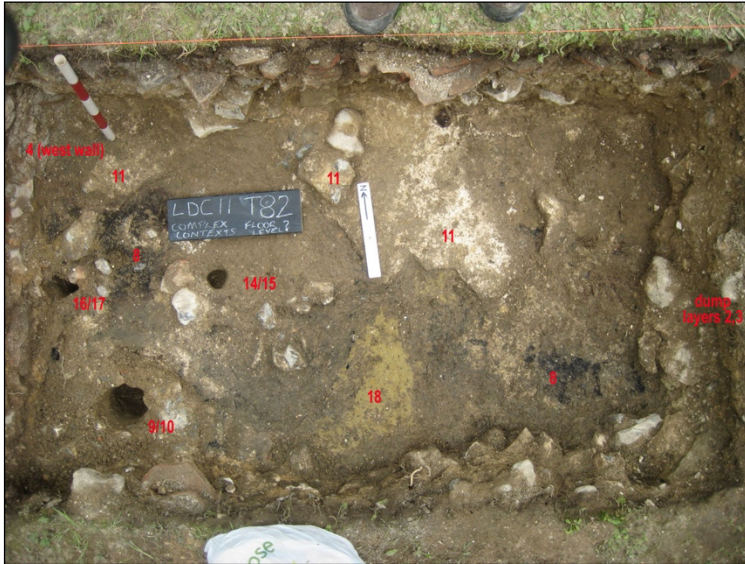
**Fig 6: 'Working floor' at base of tower.**

Four postholes (three small and one larger) penetrate [8] and [11] but not [7], and run down into the natural. There were also patches of greenish clay [18] amongst the white and burnt layers. This complex area can be seen in **Fig 6** (one small post hole yet to be excavated). There is a strong hint at a circular feature, cutting into the white and burnt layers. This activity floor (if that is what it is) lay level with the very lowest point of the west wall foundation. The basal part of the wall [5] had a peculiar orangey mortar and seemed to be composed almost entirely of Roman tile and brick [24] (**Fig 5**). The base of the east wall was not revealed but around the outside of the north and east wall ran a small plinth or ledge, except where the north east corner buttress stood. This buttress is shown in the cover picture from 1803. The north west buttress area was left unexcavated because of shortage of time.

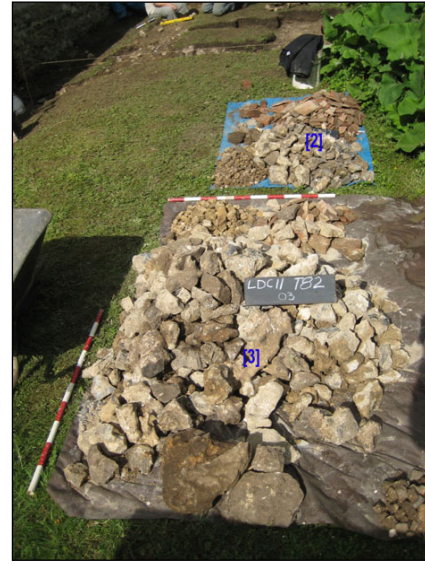
**Fig 7: Finds from [2] and [3] tower fill.**

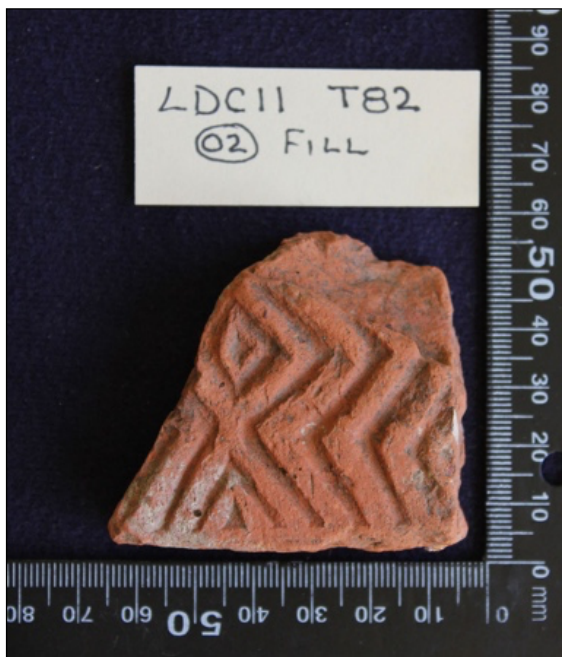
**Fig 8a: Roller stamped Roman flue tile.**

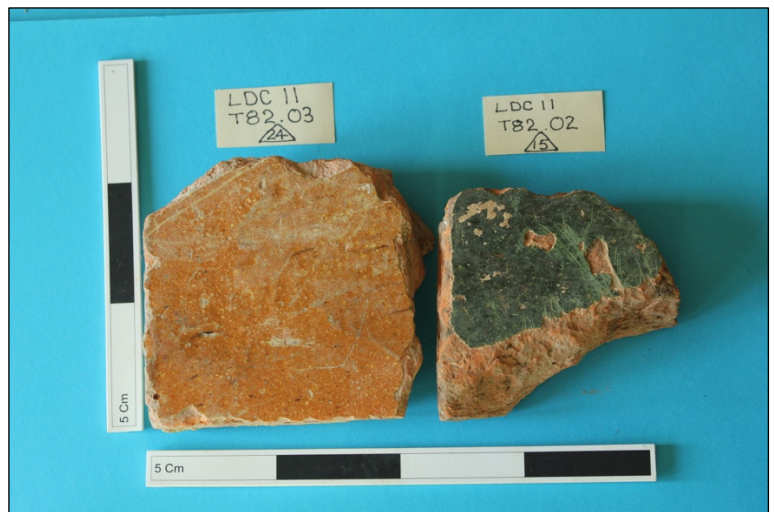
**Fig 8b: Flemish tiles, 16<sup>th</sup> - early 17<sup>th</sup> century.**

- simple medieval glazed tiles (13<sup>th</sup> century).
- late medieval Flemish tiles in yellow or green glaze<sup>8</sup> (**Fig 8b**).
- a substantial amount of lead window came fragments, mostly found in context [11] the white hard layer.
- thin window glass, some with traces of gilt lines.
- large chunks of Roman tegulae and imbrices, some of these mortared into the walls.
- Roman box flue tiles, both combed and roller stamped (type 14, according to Ian Betts)<sup>9</sup> (**Fig 8a**).
- part of a very large Roman tile, probably a sesquipedalis.<sup>10</sup>
- peg tiles.
- mortared, roughly shaped flints.
- dressed stone blocks.
- iron nails.

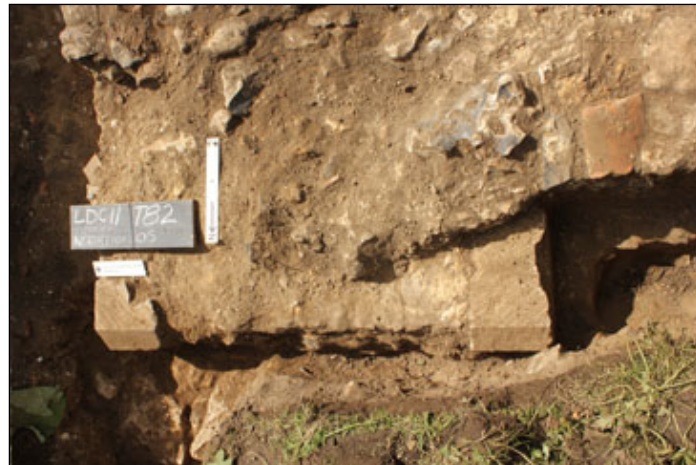
**Fig 9: Vertical view of the buttress foundation with dressed stone at the corners. Note the Roman imbrex on the right.**

Less easy to interpret was the presence on the corners of the buttress foundation of two large pieces of high-quality dressed stone with chamfered edges (see **Fig 9**). This is part of the second stage of buttress building, an event for which we do not have a date except that it is pre 1803 (the buttress is present in the print). It is odd to find such handsome pieces of stone underground as part of a foundation - perhaps the stones are also recycled 'rubbish', this time from a medieval building. Where would there be a medieval building nearby which could be robbed for stone? There are three obvious possibilities - Stone Chapel or Buckland Church, both of which went into ruin in the 16<sup>th</sup> century, and Davington Priory Church where the nun's part of the Priory church was demolished at the Reformation around 1538. All of these ruins are in neighbouring parishes.

Although it is impossible to be certain without further fieldwork, these stones are identical to medieval stonework visible in the parish church of St Lawrence, the surviving section of Davington Priory Church, where they form part of the pillars. Although the 1977 excavations of the lost part of Davington Priory<sup>12</sup> do not report having produced stonework of this kind, it is not unreasonable to suppose that the nuns section had columns the same as the surviving part. At times, Luddenham church has shared a rector with Davington and Oare e.g. Robert Harrison 1715-1755,<sup>13</sup> so there are clear connections whereby material for shoring up the shaky tower at Luddenham could have been brought in from Davington.

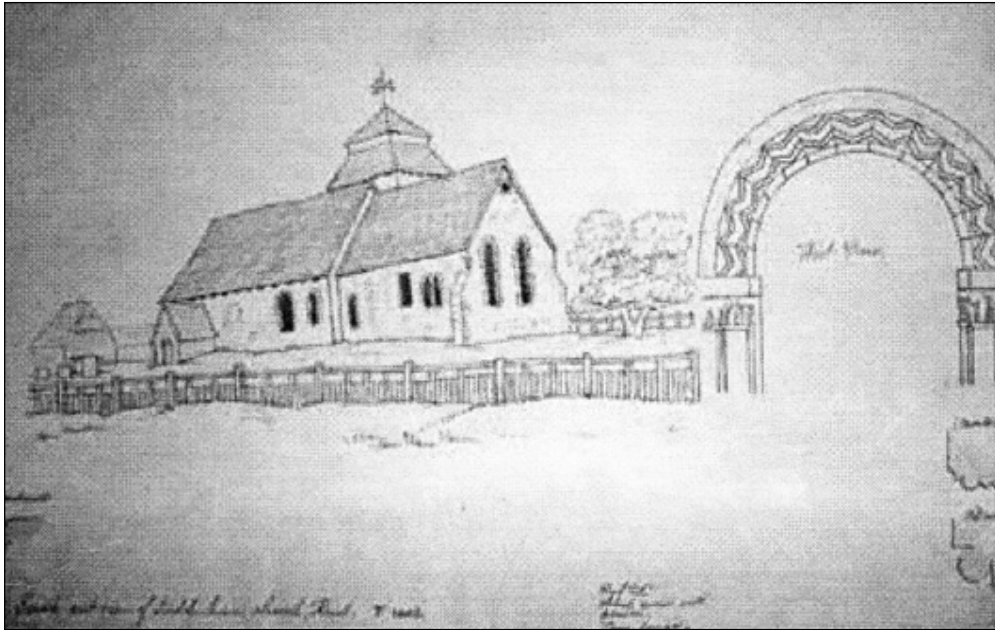
**a) 1803 Ink drawing, from the south. A Norman arch (location uncertain) is shown to the right.**

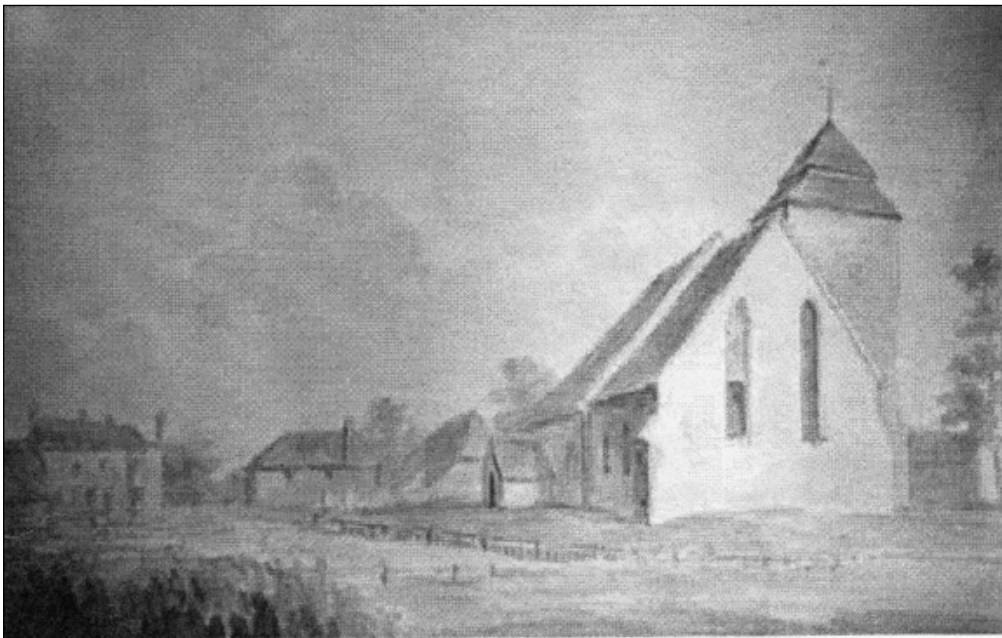
**b) 1806 Water colour by H Petrie From the south, with the manor house in the background.**
