Understanding Ospringe

Report for Keyhole Pit 81 4 & 5 Pettits Row, Ospringe Road, Faversham.

Grid Reference TR 00686 61050

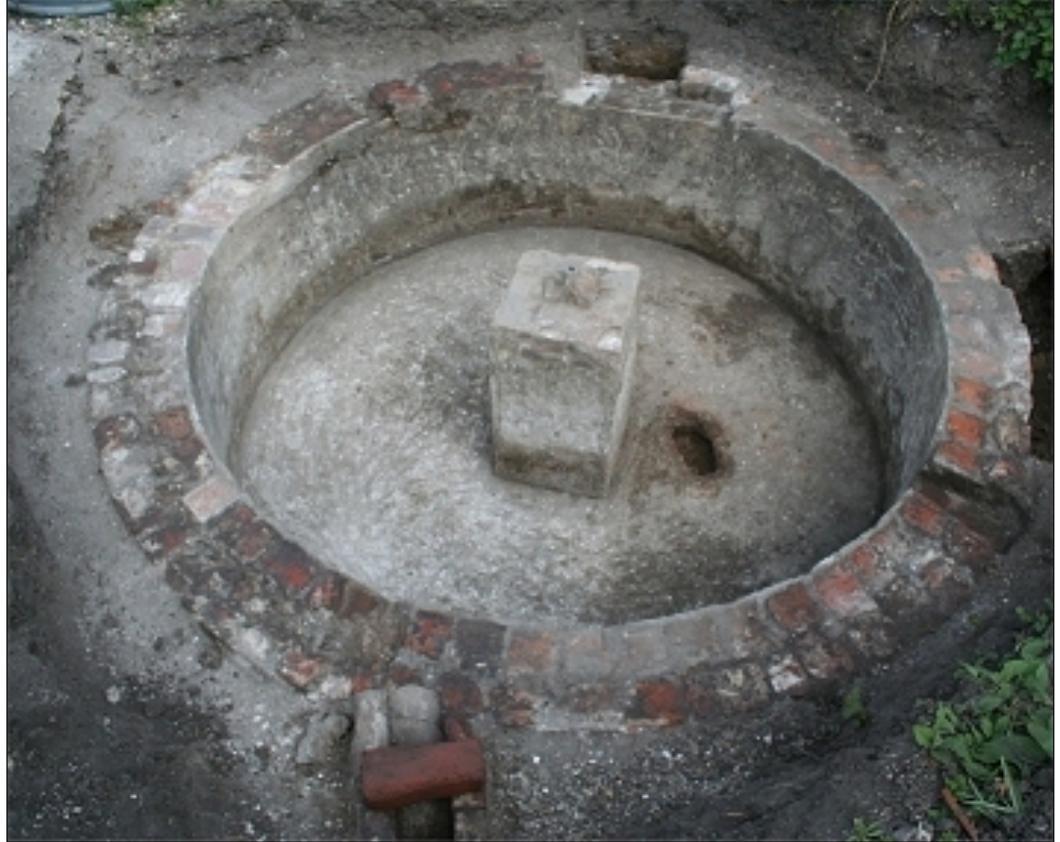
Fully excavated cistern.

Our initial evaluation was that this was a water storage vessel (cistern) and I think it's fairly safe to say this has been confirmed by our excavations. The main storage vessel (which would have originally had a higher outer wall) was some 2.6m across with an internal diameter of 2.12m and has a (remaining) depth of 0.63m. This would have given an approximate volume of 2.14m³ which equates to 2,142 litres (or 471 gallons).

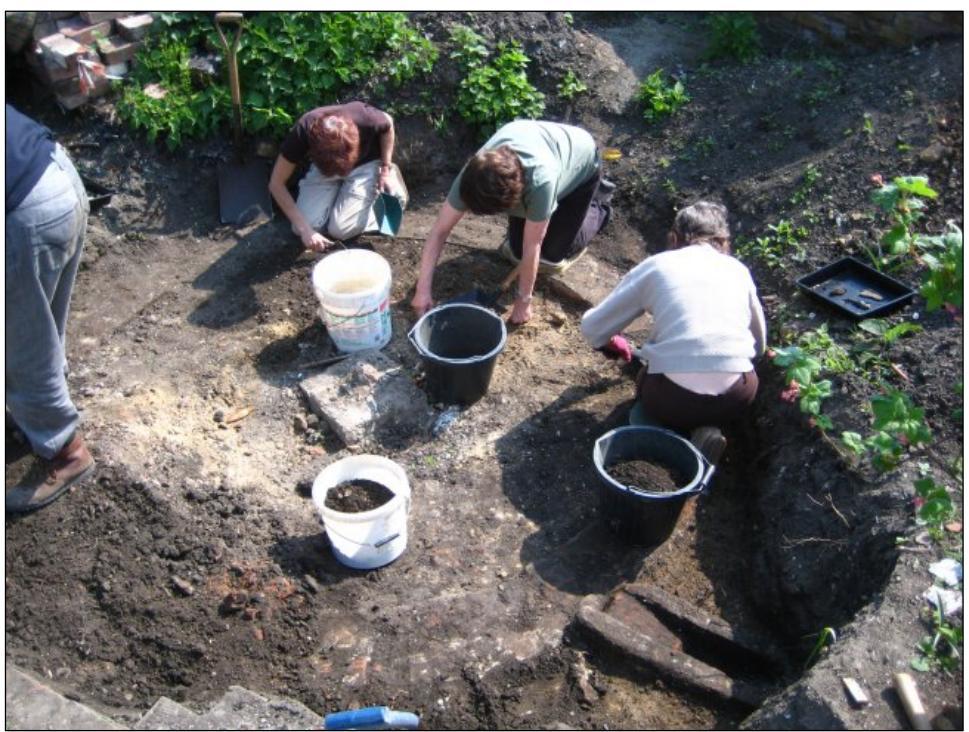
Fig 2: Work begins to reveal the structure.

As more of the brick feature became exposed, the area was expanded in order to see the complete picture. **Fig 2** shows the start of the excavation where most of the first context had already been removed by the owner Darius.

The context extended 10cm below the level that our excavation had started. Once this layer was removed, the outline of the brick structure became clear (**Fig 3**). It consisted of a main outer circular structure with another square (rendered) brick feature in the centre. Protruding vertically from the centre was a lead pipe. In addition, to the south side was a channel consisting of 2 rows of bricks with a mortared base (**Fig 4**). A brick lay at the end of the channel (as can be seen in **Fig 2**). On the inside face of the circular brick structure a rendered surface was clearly visible.

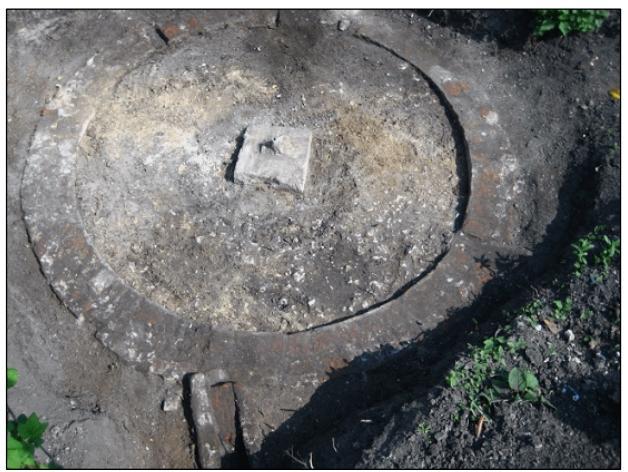
Fig 3: With the first context removed the complete structure was revealed.

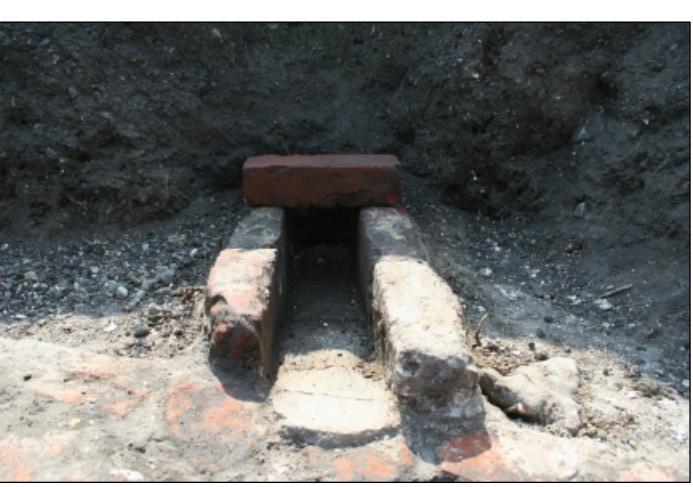
Fig 4: Channel running away southward towards the boundary wall of number 5 Pettits Row.

The channel to the south of the structure dropped away as it headed south. This suggested that this could have been an overflow runoff.

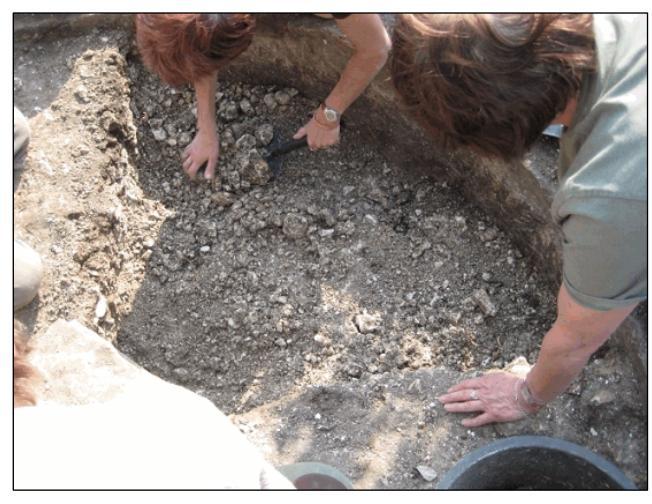
Fig 5: (02) Quadrant being removed.

Measurements were taken of the features which had an outer diameter of 2.62m, inner diameter of 2.12m and the square central brick feature was 0.36m x 0.36m. In order to excavate the next context (02) it was decided that a quadrant would be removed (**Fig 5**) in order to look at the section (**Fig 6**). Context (02) was a well compacted, well sorted chalk layer some 0.55m thick containing a small amount of varying sized flints. There were very few inclusions consisting of glass, slate, pottery, charcoal, iron, clay pipe stem and fish bone.

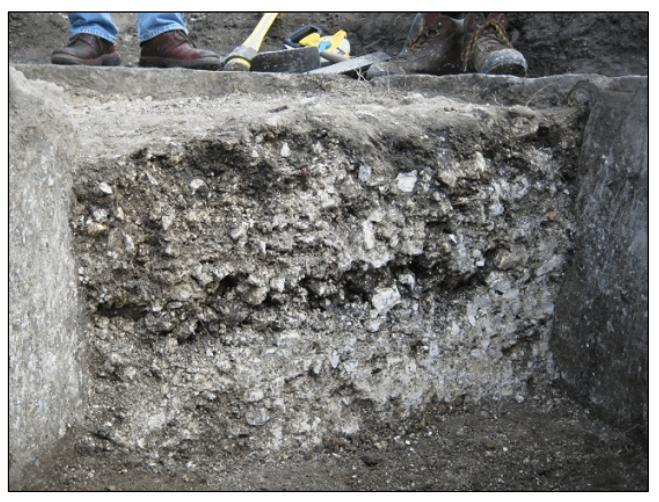
Fig 6: Section view of (02) looking east.

Interspersed within this chalk layer were lenses of dark brown soil (as can be seen in **Fig 6**). Sieving of this layer was initially carried out, but this was very unproductive with no worthwhile dateable materials being found, so was subsequently stopped. Once this quadrant of (02) was removed (**Fig 7**), what became apparent was the high build quality of the structure. This was far superior to that of the washhouses that were at the end of the gardens of Pettits Row. It certainly looked more industrial than domestic.

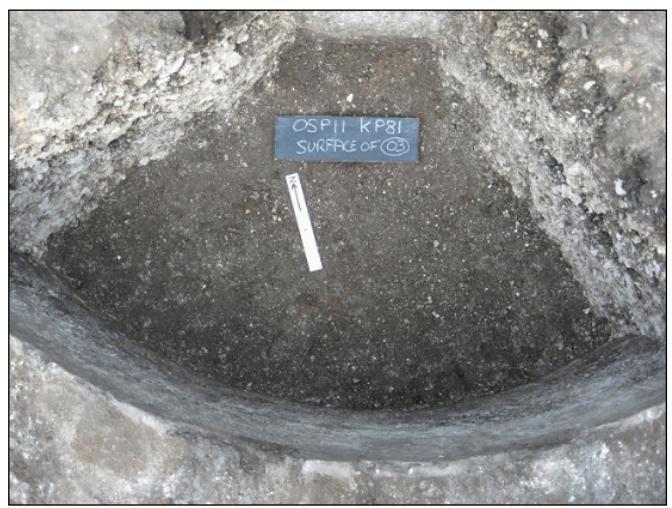
Fig 7: (02) Quadrant excavated.

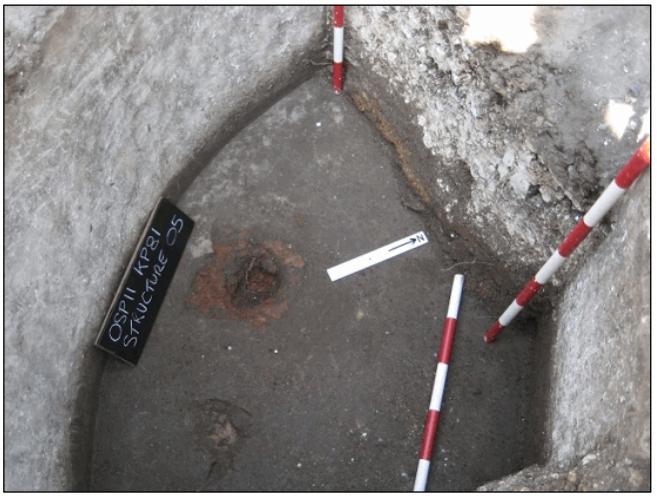
Fig 8: The base of the structure showing the rendered base with the hole.

The layer beneath (02) – context (03) – was the next to be excavated. This was a 13cm deep layer of dark brown soft soil with inclusions of bone and pieces of render. Once this layer was removed, it exposed the base of the structure. This had the same high-quality render as the inside of the outer wall. Once cleaned, a hole through the base was evident – almost certainly done deliberately once the structure fell out of use (**Fig 8**).

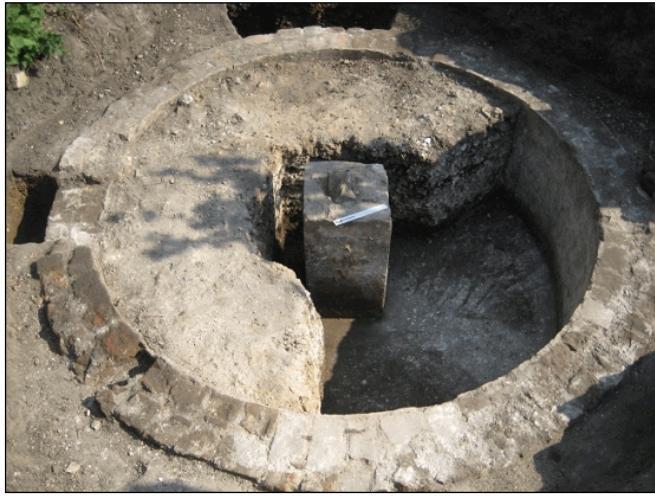
Fig 9: Revealing the lead pipe.

The base sloped downwards towards the central brick pillar dropping some 6cm. Our attention was now given to the lead pipe protruding vertically from the centre of the pillar. By pushing a rod down the centre, a bend could be detected towards the north-west. It was decided to extend the excavation of (02) and (03) on the north-west side to try and located the other end of the pipe (**Fig 9**).

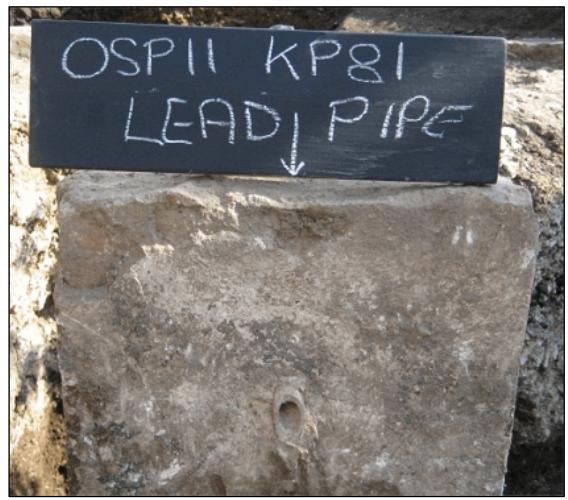
Fig 10: Lead pipe cut flush.

The pipe emerged on the north-west side some 18cm down from the top. The lead pipe had been cut off flush with the surface (**Fig 10**), but some staining on the surface of the pillar and rendering marks showed that the pipe ran vertically down the pillar to a lower level.

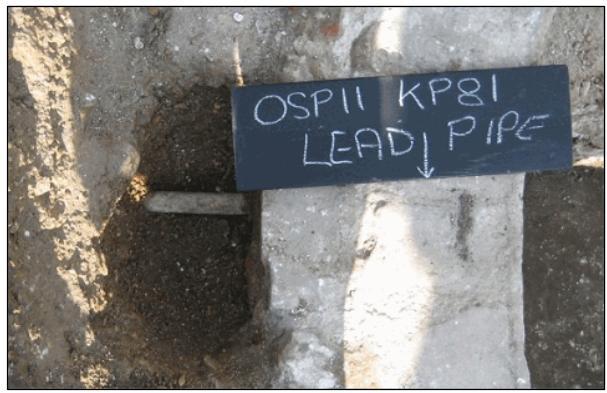
Fig 11: Second pipe north-west from the structure under the garden path.

Over on the north-west side was a second lead pipe (**Fig 11**). This pipe emerged through the wall and continued north-westerly under the garden path towards the bottom of the garden.

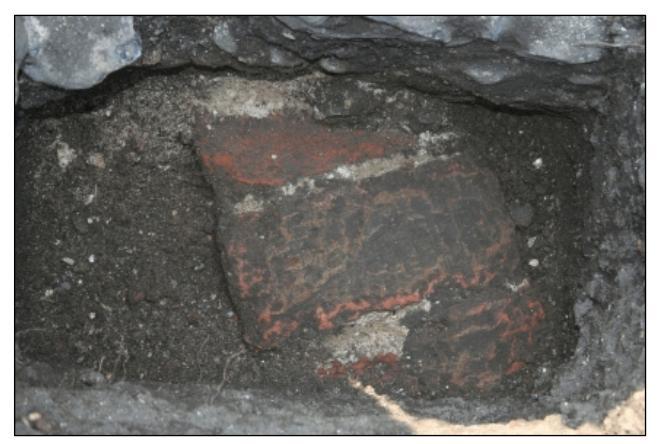
Fig 12: Channel going through flint wall.

There were two other areas that needed focusing on – the channel leading south from the structure, and whether there was any other pipework associated with it. Firstly, the channel was followed and exposed again on the north-side of the flint boundary wall (**Fig 12**). The channel was similar to those found during the Davington Priory work carried out in 2005 (**Fig 13**). The channel was then chased at the south side of the flint wall and found to terminate in an earlier drainage complex. There were various traps and a gulley visible from one of the wash houses (**Fig 14**) that appeared just below the ground surface. In order to establish the existence of any other pipework, the remaining material was removed from the inside of the circular structure.

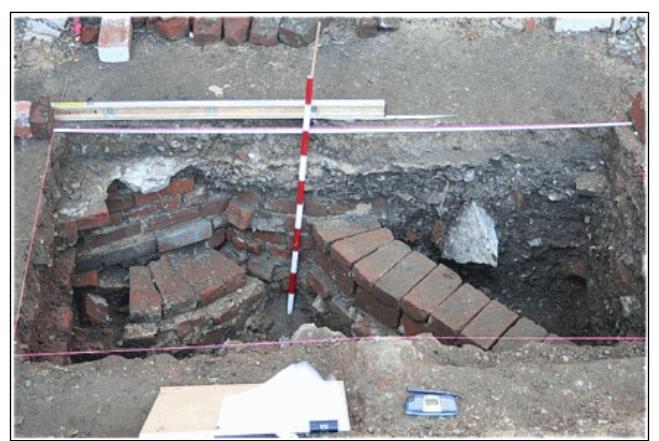
Fig 13: Similar constructed channels found at Davington Priory in 2005.³

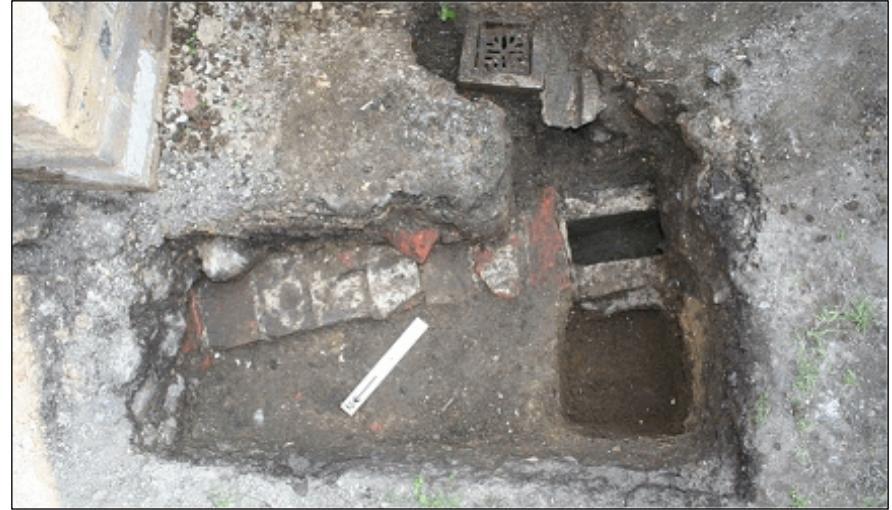
Fig 14: Showing the gulley and drain complex.

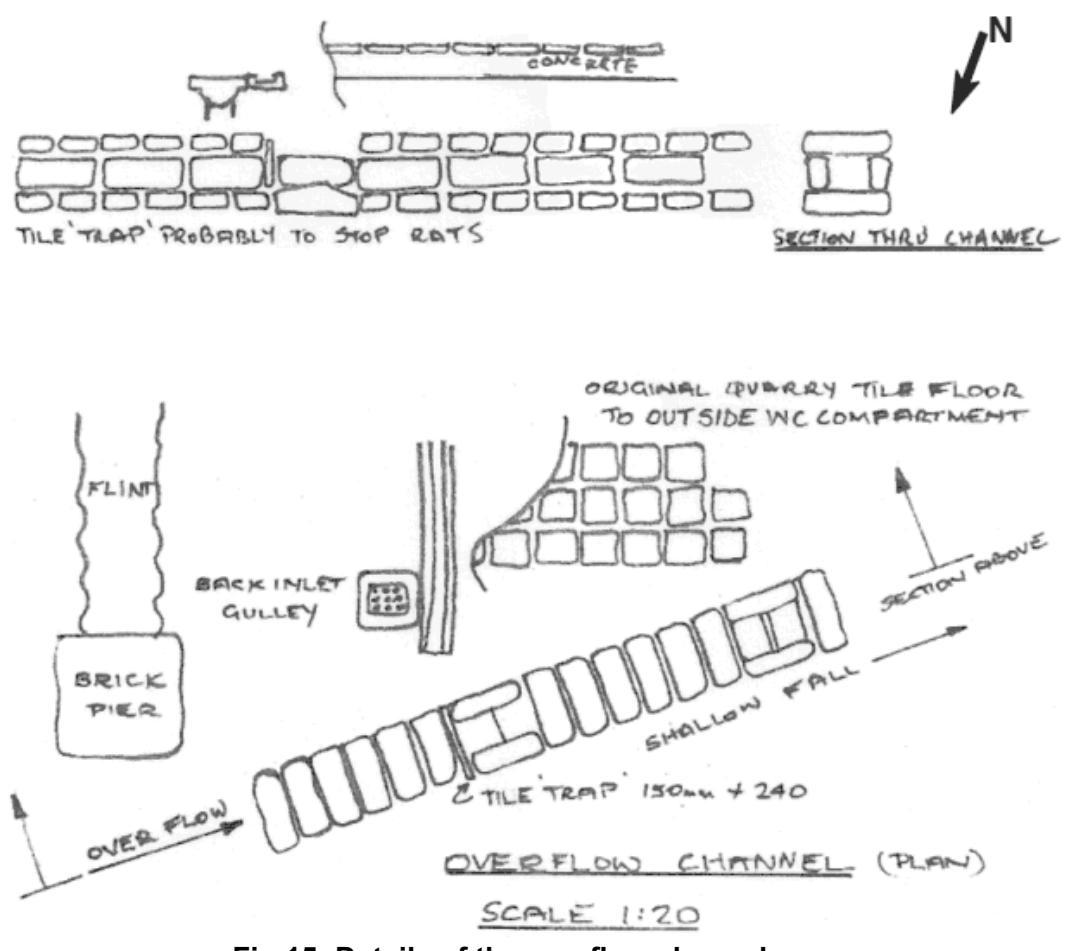
Fig 15: Details of the overflow channel.

At a point 22cm below the adjacent quarry tiled floor surface of the former outside WC compartment the top surface of the covering brick course of the 'overflow channel' was located. An area 1m in length was excavated which revealed a feature lacking the covering brick course as detailed in the drawing on the right. The feature showed a tile built vertically into the channel. This is probably a form of 'trap' designed to prevent rat access to the possible soak-away. The covering two bricks were probably left un-mortared to allow the trap to be cleaned. The distance from the main structure to the 'tile trap' was 2.9m.

The bed of the channel showed a double sloped cement feature as detailed in the drawing (**Fig 15**). Though the fall of the channel is very shallow, this feature may have been designed to maintain a low level of water within the channel to prevent mouse access. The channel continued under the existing shed, which prevented further excavation. The continuation was probed to a distance of 1m from the original 'trap' at which point it was obstructed – possibly by another 'trap'. Situated 15.5cm above the 'overflow channel' was a salt-glazed back inlet gulley and concrete channel associated with the quarry tiled floor.
